**“The property is currently in the final stages of completion and we will publish further photos when they come available.”**

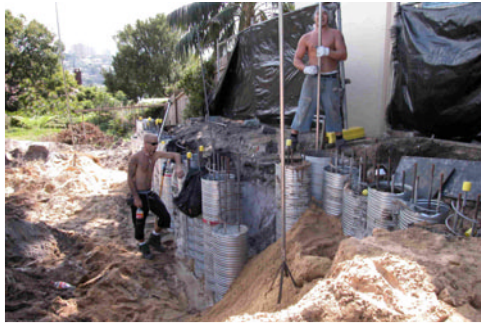
**The process of concrete piling is carried out.**

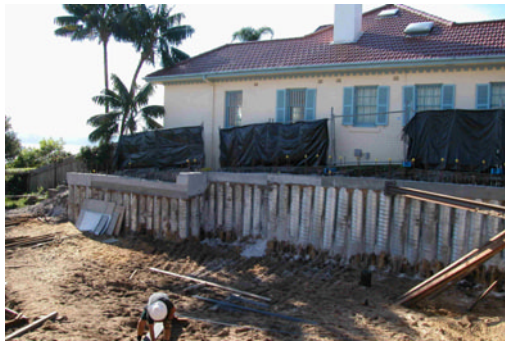
**The concrete pile retaining wall is finished complete.**

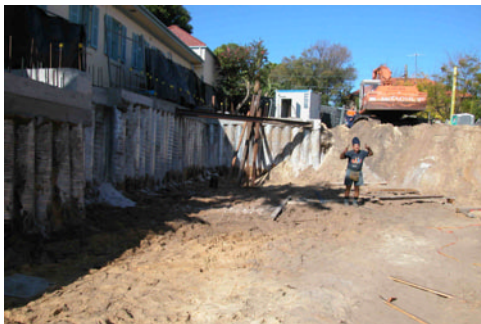
**Excavation for the lower ground floor is complete.**

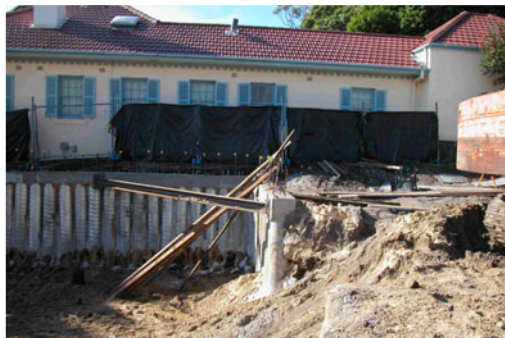
**Steel strut is installed to brace wall. The brace provided efficiently through a shallower pile depth.**

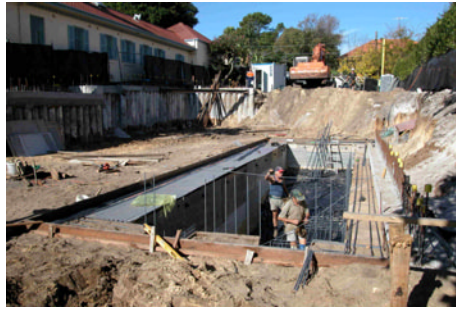
**Construction of the “indoor” pool has begun with formwork done and steel fixing. Note the concrete and reinforcement to the right of the pool. The concrete is part of a contiguous pile wall required to retain the neighbouring property during the construction of the pool.**

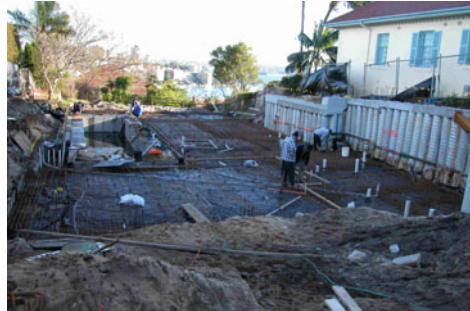
**Steel reinforcement and plumbing in place for the placement of the lower ground floor concrete.**

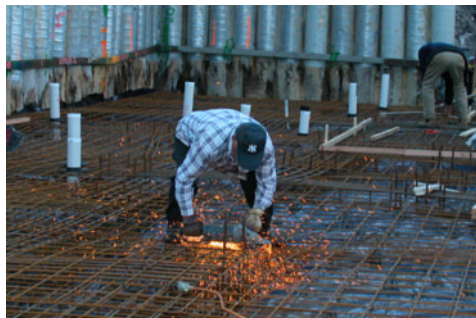
**The final touches. Concrete cover (thickness) to reinforcement is important.**

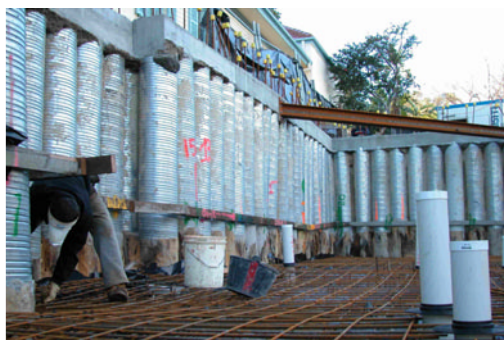
**Steel fixing. The location of the steel reinforcement within this depth of the concrete is paramount.**

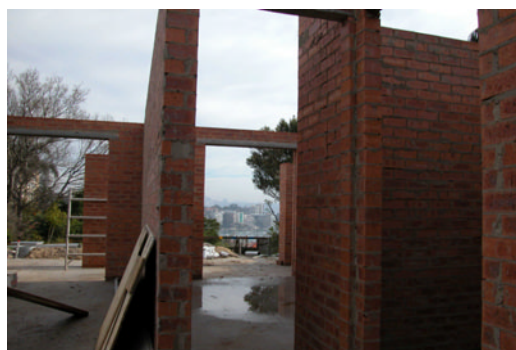
**The lower ground floor slab is poured, brick work is under way.**

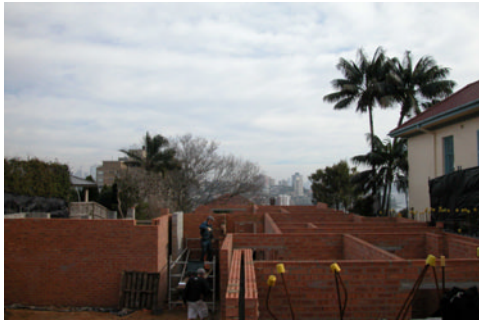
**Lower ground floor walls complete and ready to accept the ground floor slab.**

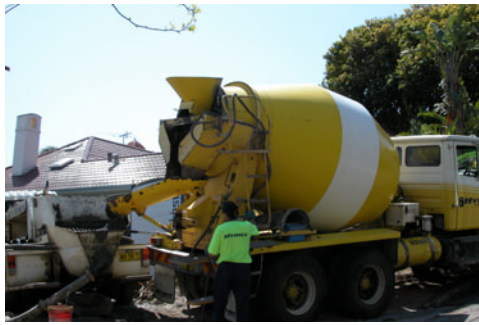
**The concrete for the ground floor slab has arrived and is being pumped.**

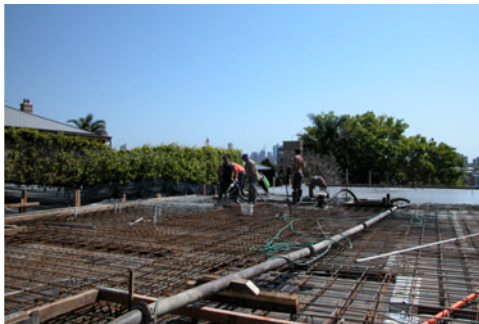
**Concrete placement for the ground floor is well under way.  
Note the steel tube that carries the concrete into position.**

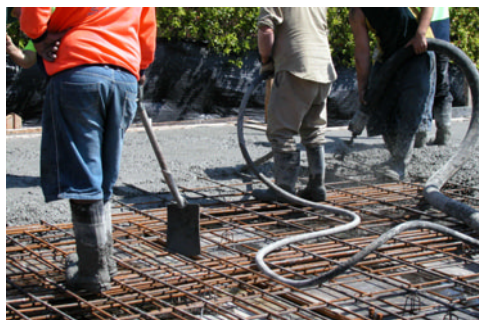
**Concrete pump/placement on right. Vibration/compaction in the middle.  
Man leaning on shovel on the left. When working the shovel bearing person assists in levelling the  
concrete for the screeder (or finer levelling) level the concrete.**

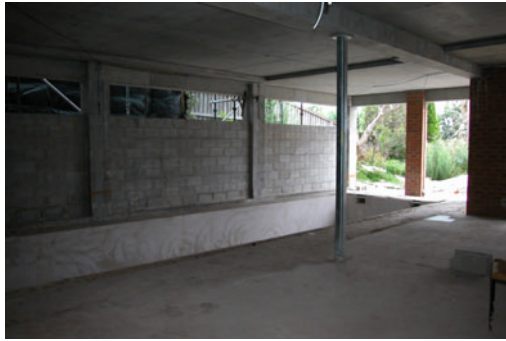
**Lower ground slab complete, ground floor complete cover and the indoor pool evident in the brick ground.**

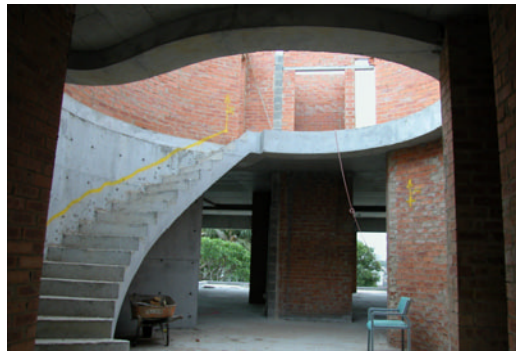
**The feature stair has taken shape.**

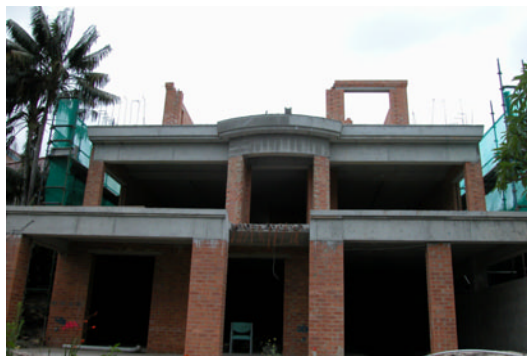
**Rear elevation – all floors now in place. The brickwork for the first floor is underway.**

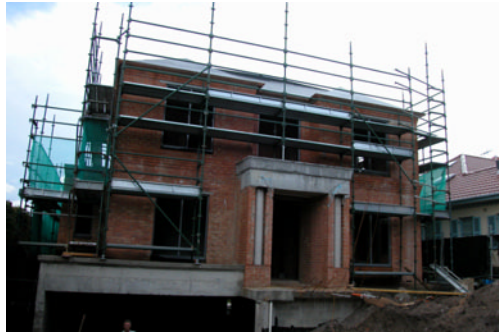
**The scaffolding is in position, ready for the external finishes to be applied.**

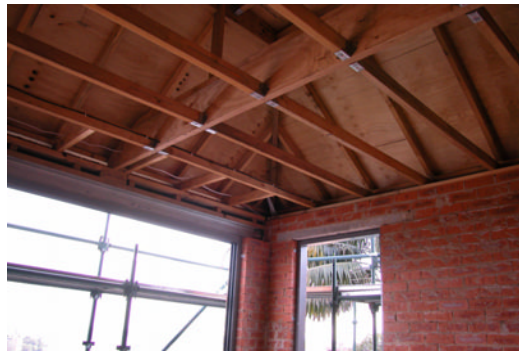
**The conventionally framed timber roof structure.**

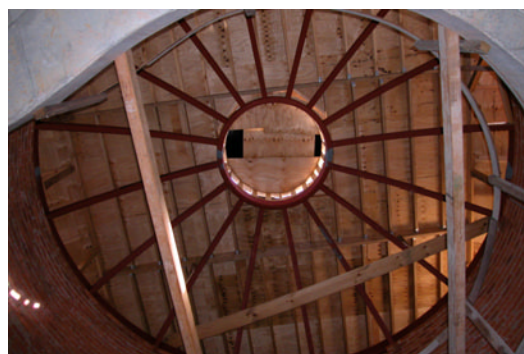
**The steel framed dome in place.**

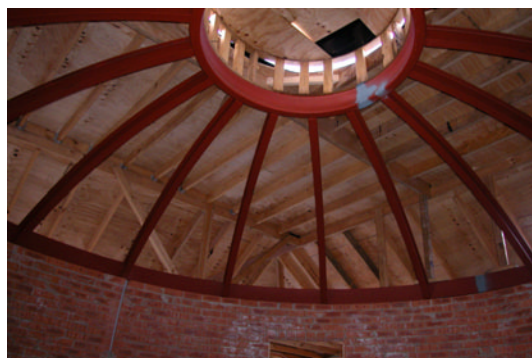
**The domed ceiling takes shape.**

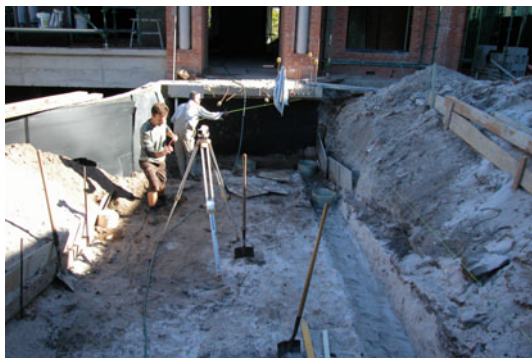
**Preparation for driveway slab and adjacent reinforced concrete block retaining wall.**

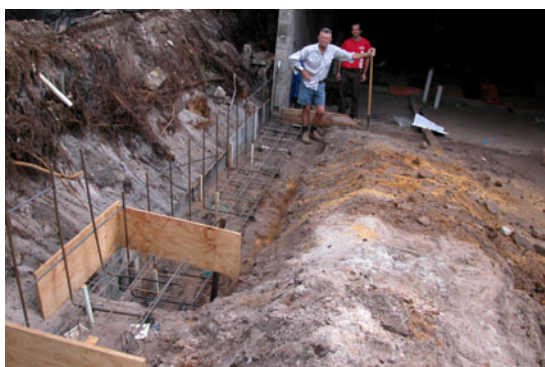
**Footings and reinforcement for the concrete block retaining wall ready to go.**

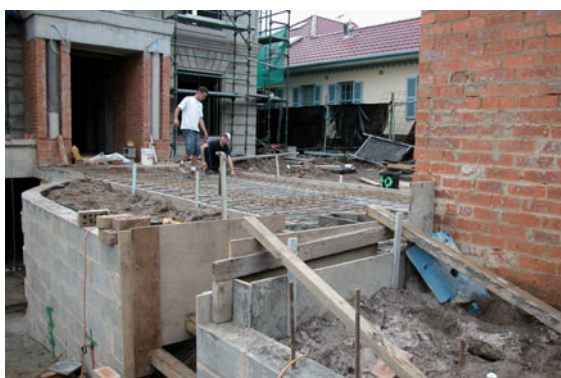
**Entry paths ready to pour.**
